Devil's Slide/Hwy 1 Storm Repair

Daily Updates from Bijan Sartipi

Daily Update
June 3 and 4

Devil's Slide (post mile 39.14)

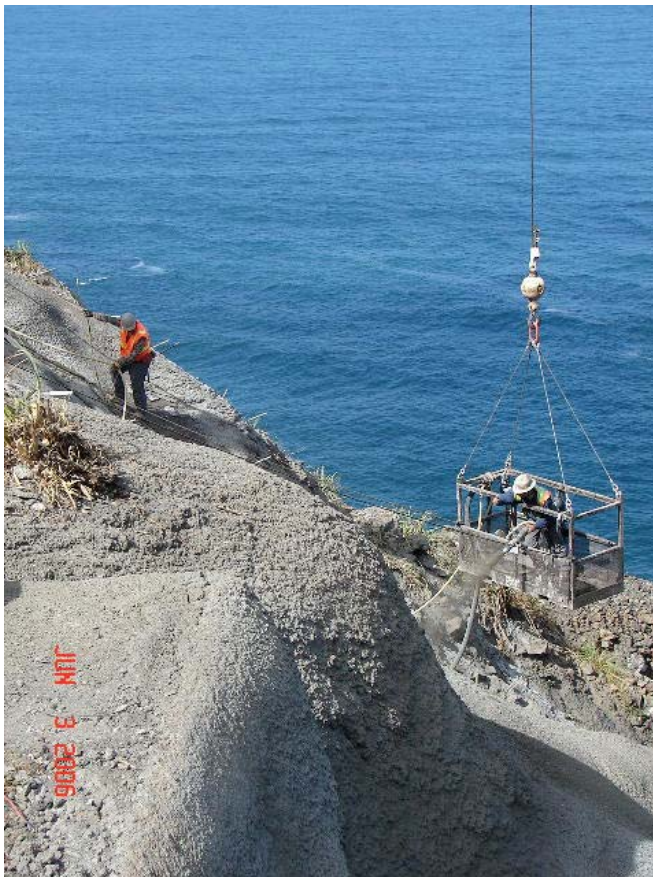
- Shotcreting below the road continued on Saturday.

Applying shotcrete to prevent erosion of the cliff surface.

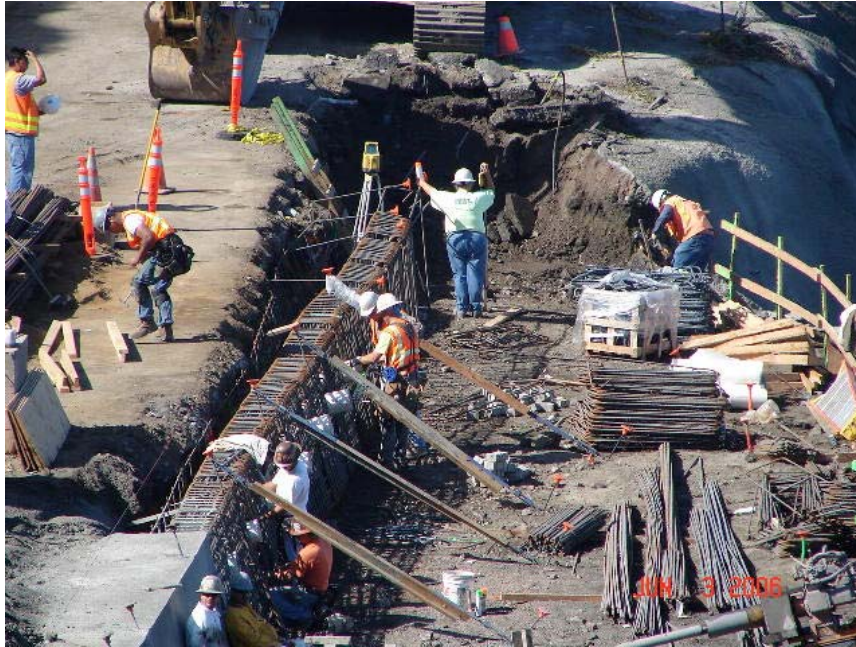
- Construction of wall 'A' continues. Approximately 50 feet of concreting was completed Saturday.

Crews continue to build bracing wall 'A' this weekend.

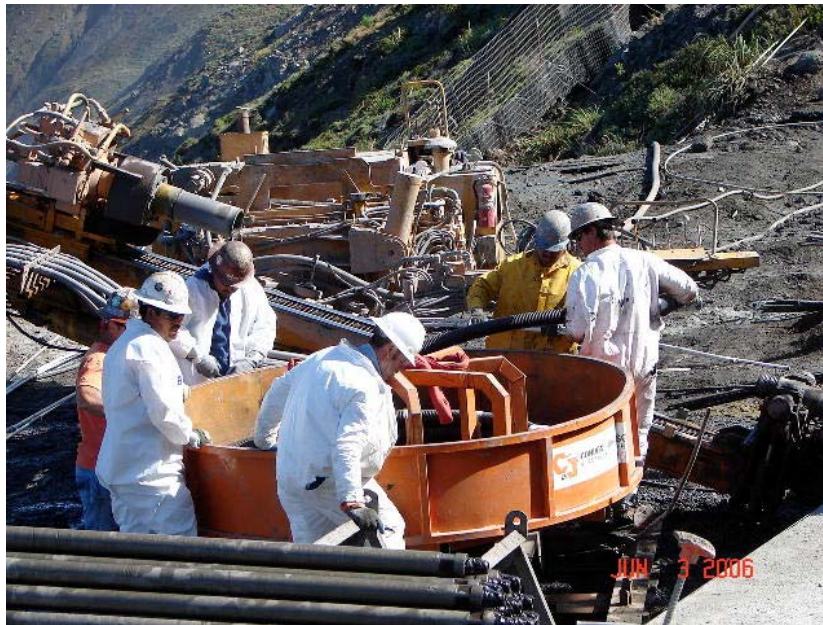
- Drilling and installation of tie backs for wall 'A' continued.

Getting ready to install another 150 feet long tie back.

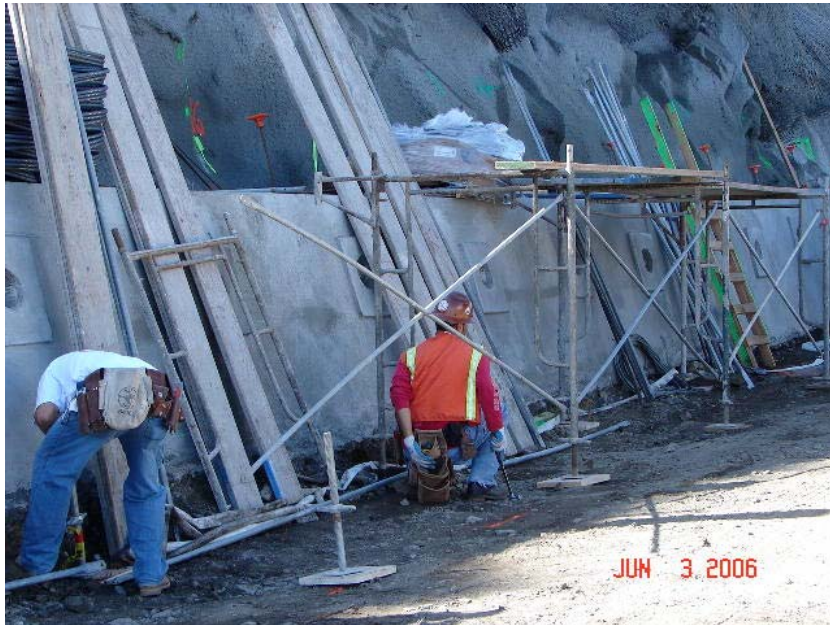
- Assembly of scaffolding for constructing the second bracing wall above the road started this weekend.

Assembling scaffolding for whaler wall 'D'.
